CHANGES IN MICROSTRUCTURE OF TURBINE WHEEL MADE OF INCONEL 713 LC

Podrábský T.¹, Juliš M.¹, Pospíšilová S.¹, Němec K.¹, Hrbáček K.², Rek A.³, Jonšta Z.⁴

¹ *Technical University in Brno, Faculty of Mechanical Engineering, Czech Republic*

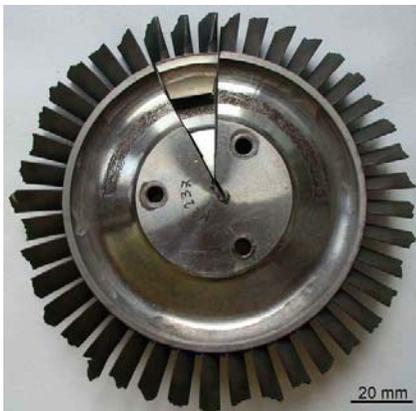
The PBS a.s. Velká Bíteš plant received one used turbine wheel manufactured of Inconel 713LC (Figure 1) and one new wheel made of the same material. In the test operation the used wheel underwent 483 startups during 87 hours and 45 minutes; with the last cycle completed, the engine was inspected and the edge sections of blades on the tested wheel were found burnt.

Fig.1 Used turbine wheel

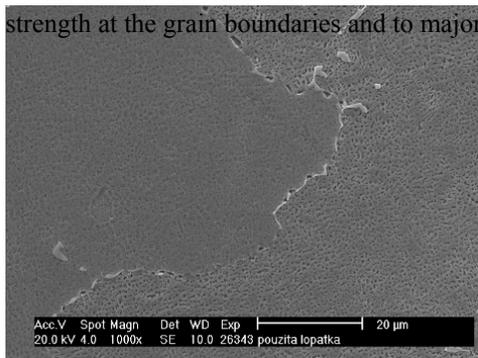
To arrive at an objective assessment of the structural changes experienced by the turbine wheel during the test operation, the structures being compared were those of samples taken from the used and the new wheels made of material from the same heat (Y 22). Under the optical microscope, and especially under the scanning electron microscope, we have observed a substantial volume of secondary carbides developed throughout the test operation at the grain boundaries in the form of continuous chains (Figure 3 and Figure 4) leading to the loss of strength at the grain boundaries and to major degradation of the material properties.

Fig.3 Microstructure, the used blade, central section, SEM, 1000x

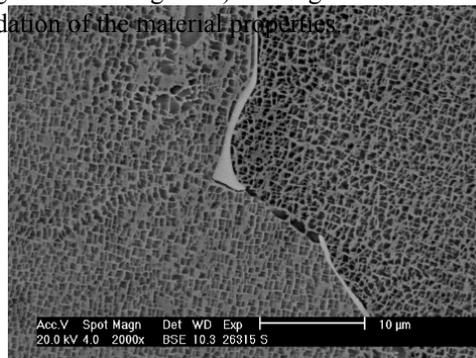
Fig.4 Secondary carbides, the hub of the used wheel, SEM, 2000x

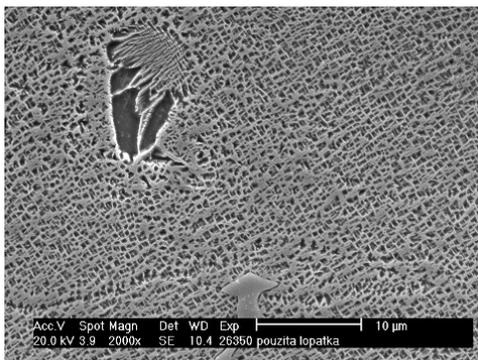
The morphology of the γ' strengthening phase was observed with SEM and the structure of blades in the used turbine wheel was found substantially changed; the changes progressed from the hub towards the blade tips, which were destroyed by burning. The wider section of the blades (closer to the hub) exhibited some isolated γ' phase precipitates in the γ matrix and an enhanced volume of the eutectic (Figure 5). At the central section of the blades the high temperatures gradually and with ever increasing intensity dissolved the γ' precipitates (Figure 6), thus giving rise to an oversaturated solid solution. Towards the tip - where the blade

Fig.5 Precipitates γ' in γ matrix; the used blade; closer to the hub; SEM, 2000x

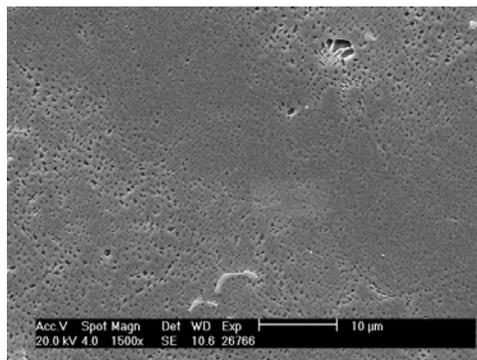
Fig.6 Partially dissolved precipitates; the used blade; central section; SEM, 2000x

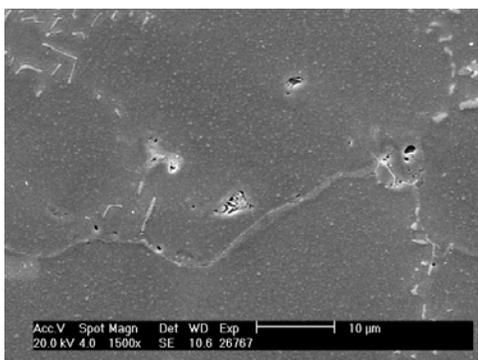
is thinnest and exposed to the highest temperatures - the strengthening γ' phase particles were already fully dissolved in the solid solution (Figure 7). Since this section of the blade was cooled faster, no new γ' phase particles were developed here as witnessed by the conspicuous discoloration of the blade surface. The structure at the thin end of the blades exhibited just very small areas of secondary carbides, at some places surrounded by still partially undissolved and coarsened γ' phase precipitates (Figure 8).

Fig.7 Dissolved γ' precipitates; the used blade; edge section; SEM, 2000x

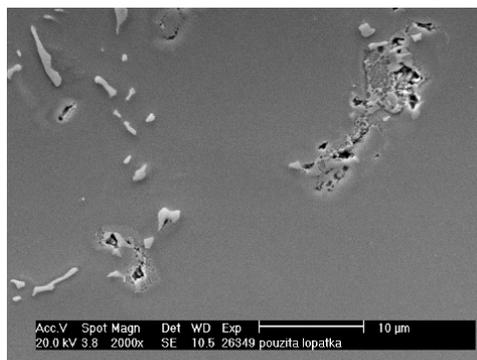
Fig.8 Partially undissolved γ' precipitates around the secondary carbides; edge; SEM, 2000x

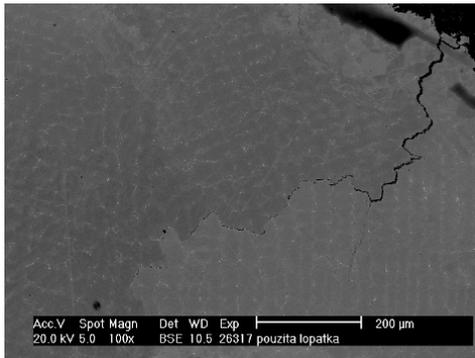
The SEM observations have proven true the hypothesis that the initiation and propagation of cracks in the alloy structure are closely related to the secondary carbides developed at the grain boundaries (Figure 9 and Figure 10), where the cracks were revealed most often. The EDS microanalysis performed on various sections of the used wheel blades proved that the chemical compositions were identical.

Fig.9 Crack at the grain boundary; the used blade; SEM, 100x

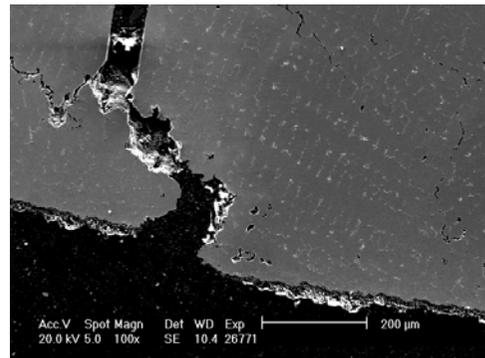
Fig.10 The crack detail; the used blade, SEM, 100x

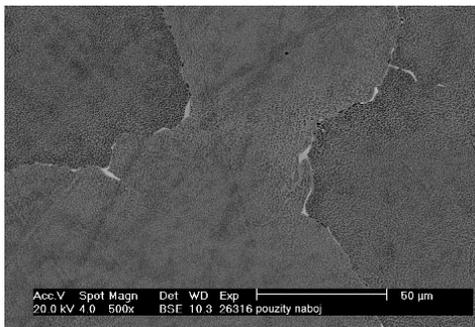
In contrast to the blade samples, the samples taken from the used wheel hub showed no major changes in the morphology of the strengthening γ' phase precipitates, but the structure was found, once again, to contain secondary carbides developed at the grain boundaries (Figure 11 and Figure 12). The EDS microanalysis disclosed that the secondary carbides developed consisted mainly of Nb, or possibly of Ti and Cr.

Fig.11 Secondary carbides at the grain boundary; the used wheel hub; SEM, 500x

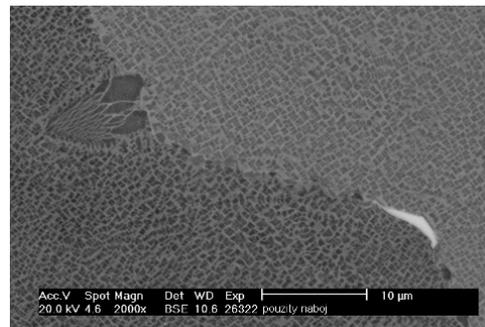
Fig.12 Microstructure, the used wheel hub, SEM, 2000x
