COMPARING REJUVENATED MICROSTRUCTURES AFTER HIP PROCESS AND DIFFERENT HEAT TREATMENTS IN CAST NICKEL BASE SUPERALLOYS, IN-738 AND GTD-111 AFTER LONG-TERM SERVICE

Wangyao P.¹, Krongtong V.², Homkrajai W.³, Polsilapa S.⁴, Lothongkum G.⁵

The aim of this research work is to determine the most suitable and practicable repair-condition, which provides the best microstructural characteristics by rejuvenation method of hot isostatic pressing (HIP) followed by various heat treatment for long term exposed gas turbine blades, casting nickel base superalloy after 50 000-hour service operated by Electricity Generating Authority of Thailand (EGAT).

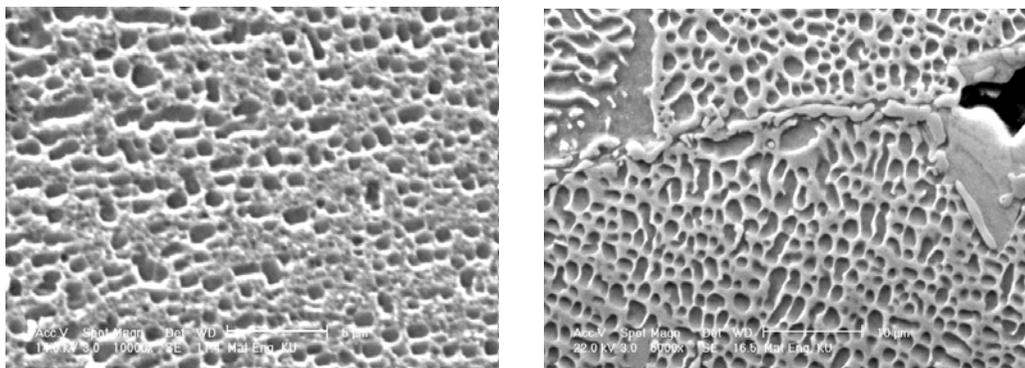
Optical microscopy photographs, obtained from the transverse sections at about mid blade height of the airfoil, are shown in Fig. 1. The microstructure of as-cast alloy generally consists of extensive precipitation of ordered L1₂ γ' intermetallic phase within dendrite core and in the interdendritic region. Carbides/carbonitrides predominantly MC type, borides, sulphur-carbide and γ-γ' eutectic which form during ingot solidification are found in smaller volume fraction locating along the interdendritic region as well, according to works [14].

Microsegregation during ingot solidification causes the formation of non-equilibrium γ-γ' eutectic. The chromium carbide (M₂₃C₆) and agglomerated gamma prime and secondary gamma prime particles can be seen. Coalescence of the primary and secondary gamma prime particles, as result of long-term service, seems to occur resulting in larger and rounded particles. It was also reported that eutectic gamma prime islands as well as elongated gamma prime partials are observed as well in the works [15 - 16]. This is most probably due to the slow cooling rates. From work [2], reported that the some of these grain boundary carbides had precipitated during long-term service at elevated temperatures (760°C to 982°C), where

chromium carbide could precipitate. Usually, in the undegraded root sections, the carbides are discontinuous along the grain boundaries and provide grain boundary strength. However, coarsening of these precipitates and the formation of continuous grain boundary carbides and/or gamma prime phases normally lowers ductility or toughness of blade alloy. This can lead to lower creep strength and impact resistant of the blades.

Fig.1 As-received microstructure after long-term service showing the coalescence of γ' particles, areas of γ - γ' eutectic and grain boundary carbides, IN-738 (Left) and GTD-111 (Right)

The degree of degradation in both alloys, as measured by the gamma prime particle size, increases with exposed time and service temperature. In this study, however, the coarse gamma prime particle size was about 1.2 and 2.5 μm for IN-738 and GTD-111, respectively. The airfoil microstructure shows significant degradation in service comparing to the microstructure of the root section. The primary gamma prime particles have spheroidized and secondary gamma prime coarsened in the airfoil samples. This type of microstructure is theoretically expected to have low efficiency to block dislocation movements during loading at high temperatures resulting in lower creep resistance. Therefore, it is needed to recover microstructure to the same as or similar to the original one by simple re-heat treatment processes.

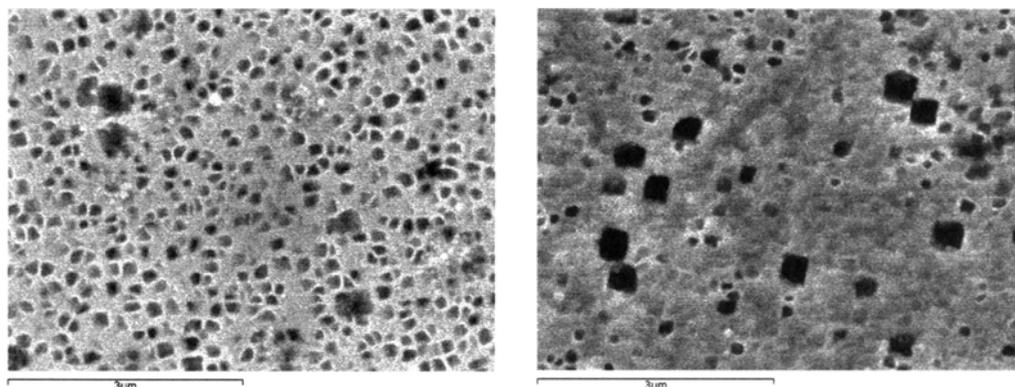
Fig.2 HIPed microstructure showing partial dissolved gamma prime particles, IN-738 (Left) and GTD-111 (Right)

It was found that the amount of remain microvoids decreased drastically when HIP time was increased. Therefore, by SEM investigation in specimens, it was found that the microvoids were very rarely to be detected. This fact is very important to consider about the advantage of HIP process for refurbishment of superalloy components. Figure 2 shows the etched microstructure of HIPed specimen with the uniform dispersion of smaller coarse gamma prime particles, which previously were partially dissolved into the matrix during HIP at high temperature. It should be noted that the previous coarse gamma prime particles could not be solutioned completely at 1200°C for 5 hours for both alloys.

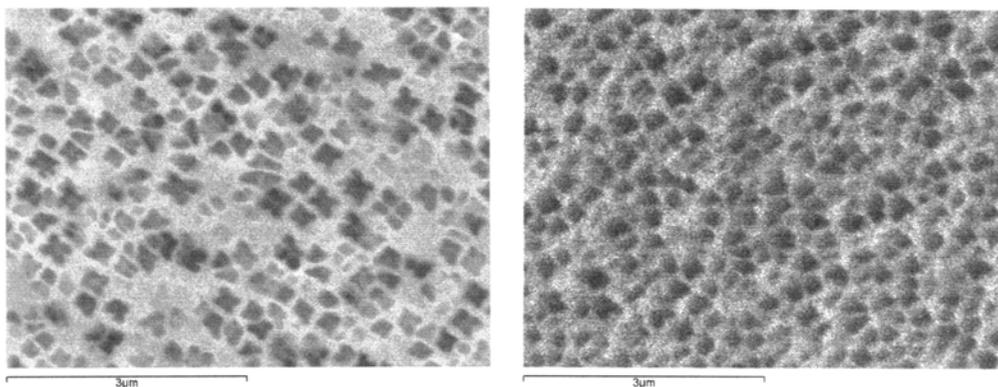
The microstructures of HIPed specimen followed with the only secondary aging shown in Fig. 3. The heated treated microstructure according to program No.1 contains the homogeneous distribution of very fine γ' particles precipitating in the matrix as nearly cubic shape. It should be noted that the microstructure contains with only single size of precipitated γ' particles, which have the size in the range of 0.2 - 0.4 μm . In both cases, it could be considered that heating during HIP process also working as solution treatment at 1200°C for 5 hours and then followed by simple secondary aging at 845°C for 24 hours. The previous precipitated γ' particles could nearly be dissolved into matrix in some degree during HIP process. Therefore, when secondary aging was applied then the γ' particles could reprecipitate again in very fine size with uniform distribution.

Fig.3 After heat treatment at 845°C/ 24 hrs. (AC); Condition No. 1, IN-738 (Left) and GTD-111 (Right)

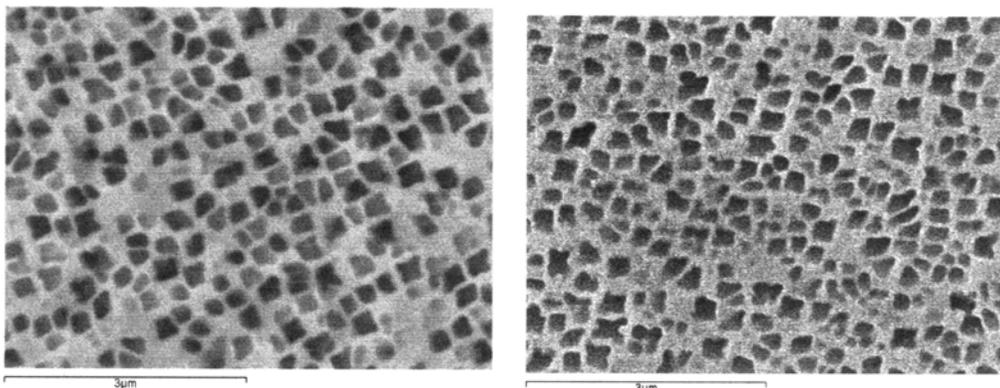
Figure 4 shows the heat-treated microstructures according to the program No. 2 with the additional primary aging at 925°C for 1 hour. The microstructures are very similar to heat-treated microstructure of program No. 1. In both cases, the received microstructures consist of uniform distribution of precipitated γ' -particles as in single size in the range of 0.25 - 0.4 μm . However, comparing microstructures according to program No. 1, it can be seen that the added primary aging at 925°C for 1 hour could result in more uniform precipitation of γ' particles with slightly higher volume fraction and γ' particles becoming more cubic shape.

Fig.4 After heat treatment at 925°C/ 1 hr. (AC), and 845°C/ 24 hrs. (AC); Condition No. 2, IN-738 (Left) and GTD-111 (Right)

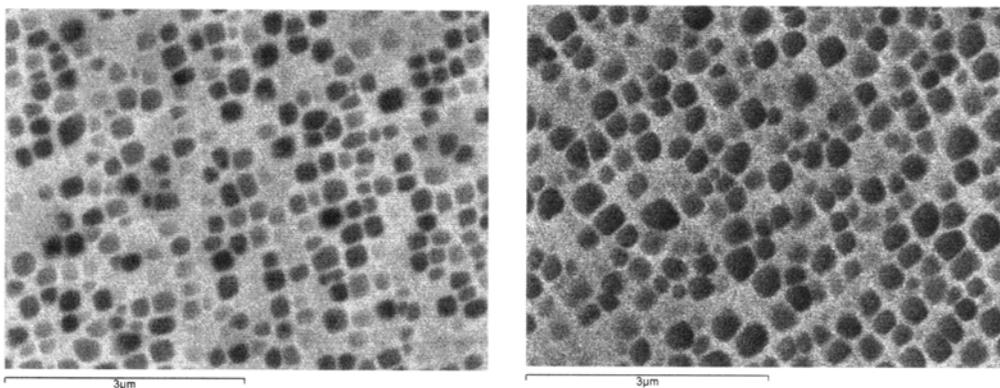
Figure 5 shows the heat-treated microstructure according to program No. 3 with an inserted primary aging at 1055°C for 1 hours before the secondary aging comparing to microstructure of heat treatment program No. 2, it could be noted that this inserted primary

aging with higher temperature resulted in more uniform distribution of finer γ' particles, especially in microstructure of GTD-111. Furthermore, these γ' particles also became closer to cubic shape with the single size. Both microstructures are the most similar to each other after this heat treatment conditions and 0.2 - 0.4 and 0.3 - 0.6 μm for IN-738 and GTD-111, respectively.

Fig.5 After heat treatment at 1055°C/ 1 hr. (AC), and 845°C/ 24 hrs. (AC); Condition No. 3, IN-738 (Left) and GTD-111 (Right)

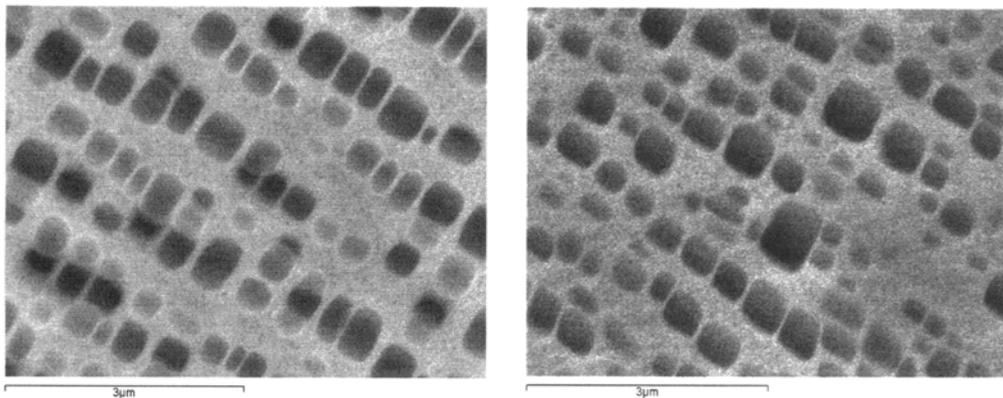
Figures 6 - 8 show the HIPed microstructures following with the additional solutioning before the secondary aging and/or primary and secondary aging. The additional solutioning step could strongly provide the difference of microstructure characteristics comparing to those heat-treated microstructures without any solutioning. Heat-treated microstructure according to program No. 4 shows the homogeneous distribution of precipitated coarse γ' particles after secondary aging at 845°C for 24 hours, Fig. 6. The additional solutioning step could result in the early step precipitation of very fine γ' particles which could continue to precipitate in coarser cubic particles during secondary aging. Very fine precipitated γ' particles were very difficult to be detected clearly in these microstructures.

Fig.6 After heat treatment at 1125°C/ 2 hrs. (AC) and 845°C/ 24 hrs. (AC); Condition No. 4, IN-738 (Left) and GTD-111 (Right)

4. Heat-treated microstructures according to program No. 4 should probably be the most proper for long-term service, especially in creep load condition for both alloys. Microstructures of IN-738 according to programs 5 and/or 6 should provide the combination of tensile and creep strength due to the bimodal γ' particles.

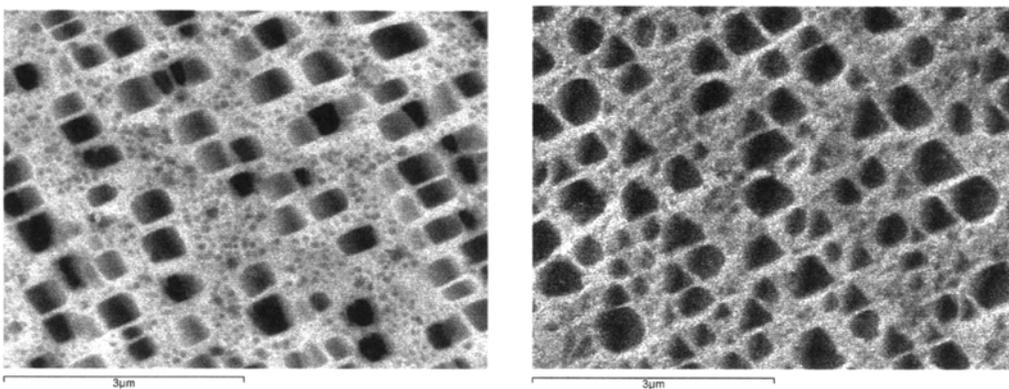
Fig.7 After heat-treatment at 1125°C/ 2 hrs. (AC), 925°C / 1 hr. (AC), and 845°C / 24 hrs. (AC); Condition No. 5, IN-738 (Left) and GTD-111 (Right)

When the inserted primary aging was applied between solutioning and secondary aging step, the very fine precipitation of γ' particles were obviously found among the coarse

cubic γ' particles; as shown in Figs. 7 and 8, especially in case of IN-738. This might be due to that the inserted primary aging allowed microstructures to precipitate these very fine γ' particles in very small size before secondary aging and continuing to grow in some degree during the last aging. However, it could be seen that the heat-treated microstructure according to program No. 4 is slightly higher in volume fraction of coarse γ' particles comparing to those of programs No. 5 and 6.

Figure 7 (Left) shows the HIPed microstructure of IN-738 followed with primary aging at 925°C for 1 hour and then secondary aging was applied at 845°C for 24 hours, which consists of homogeneous distribution of bimodal precipitated γ' -particle sizes. The microstructure consists of the coarser cubic γ' -particle with its size in the range of 0.2-0.5 μm and the very fine γ' particle as in near-round shape. Such microstructure is also found in heat-treated microstructure, Fig. 8 (Left) according to program No. 6 with the higher temperature during primary aging (1055°C/ 1hr.). However, the volume fraction of γ' particles is slightly less than that of heat-treated microstructure according to program No. 5. This might be due to that the lower primary aging temperature is more proper aging temperature, which could provide slightly more reprecipitated γ' particles than utilizing the higher one.

In the case of GTD-111 according to programs No. 5 and 6 (Fig. 7 (Right) and Fig. 8 (Right), respectively), it should be noted that the inserted primary aging after solutioning had significant and negative effect on microstructure and could result in the lower driving force for next secondary aging to produce the uniform precipitation of cubic coarse γ' particles. In these cases, the higher temperature of primary aging provides the lower volume fraction of coarse γ' particles in more rounded-shape and smaller size.

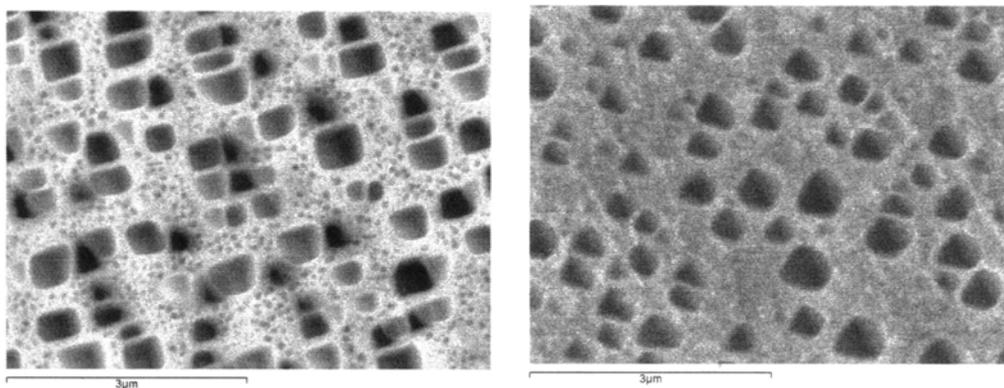
Fig.8 After heat treatment at 1125°C/ 2 hrs. (AC), 1055°C/ 1 hr. (AC), and 845°C/ 24 hrs. (AC); Condition No. 6, IN-738 (Left) and GTD-111 (Right)
