THE MICROSTRUCTURAL ANALYSIS OF TURBINE BLADE FROM ALLOY INCONEL 713 LC

Podrábský T.¹, Jonšta Z.², Hrbáček K.³, Němec K.¹

The aim of presented work is to study the microstructure of cast nickel-base alloy Inconel 713 LC after testing at the exploitation temperature. The structural changes were studied using light microscopy and transmission electron microscopy (TEM).

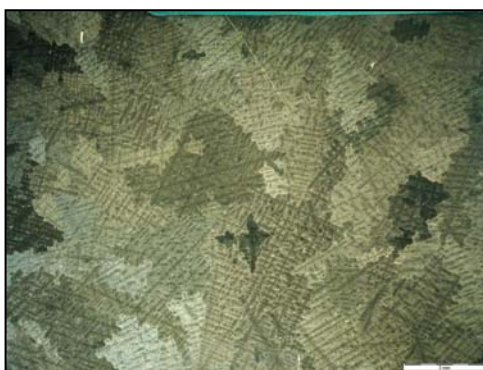
Fig. 1a Macrostructure of the lock turbine blades with dendritic segregation

The turbine blades made of Inconel 713 LC nickel-based superalloy exhibit a pronounced dendritic segregation (see Figures 1a, b). The dendrites observed in the blade root were substantially larger than those encountered in the shaped part of the blade (see Table 1); this observation can be ascribed to the higher rate of cooling experienced in the thin wall of the shaped blade part. The sizes of dendrites were determined on sections cut parallel to the sample axis; the length of the primary dendrite axis was measured.

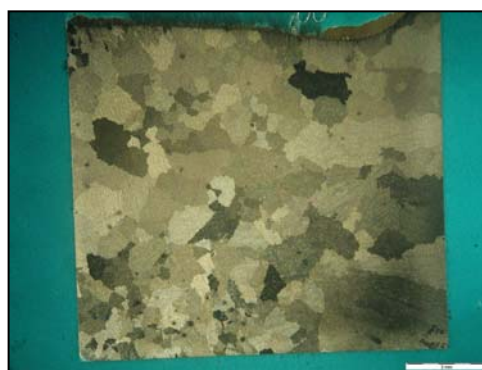
Fig. 1b Macrostructure of the surface turbine blades with dendritic segregation
