EVALUATION OF CORROSION RESISTANCE OF MIG BRAZED STEEL SHEETS

The paper presents the results of quality evaluation of brazed joints made by Gas Metal Arc Brazing (GMAB) method. The influence of brazing direction and brazing current on the quality of joints as well as the influence of brazing parameters on the corrosion resistance of joints were evaluated. The brazing was realized on the device CLOOS 303 MC4 with the shielding gas of Argon 4.60. The CuSi₃ braze was used as a filler material. A drawing-grade steel sheet DX51D was used as a brazed material. Corrosion resistance of joints was evaluated on the base of accelerated tests in three environments namely wet atmosphere, NaCl solution and atmosphere of SO₂. The duration of the test was chosen according to STN EN ISO 3231 standard, with the following number of testing cycles: 1, 2, 3, 7, 14, 21 and 28 days. The using of right-hand method of brazing causes the destruction of zinc coating in the places of joint in a longer distance from braze in comparison to left-handed method. The results were obtained from accelerated corrosion test with the most aggressive environment of SO₂.

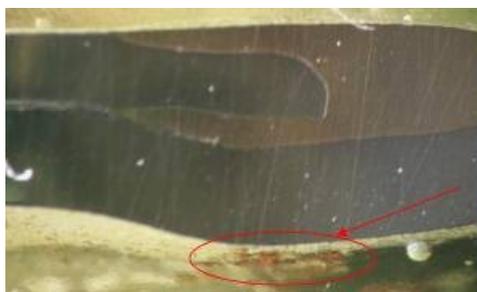
Fig.6 Detail of corrosion attack in left-hand brazing on sample F1, extension of 10x

The corrosion changes were observed only on the surface of the base material (**Fig. 6** and **Fig. 7**) in both types of brazing in the places where evaporation of zinc layer occurred. The scratch patterns confirmed staining corrosion in the back area of the overlapped joint due to the discontinuance of the coating caused by overheating during brazing (**Fig. 6**), or on the interface of the base material – brazing solder joint caused by the heat of the arc in the transfer of the melted brazing solder (**Fig. 7**). Based on mentioned it is assumed as a bimetallic corrosion.

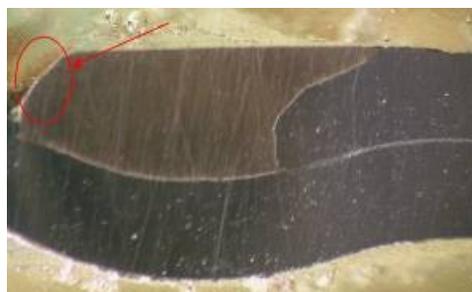
Fig.7 Sample A1 (right-hand brazing) after 240-hours exposure
