CHANGES IN MICROSTRUCTURE OF TURBINE WHEEL MADE OF INCONEL 713 LC

Podrábský T.¹, Juliš M.¹, Pospíšilová S.¹, Němec K.¹, Hrbáček K.², Rek A.³, Jonšta Z.⁴

¹ *Technical University in Brno, Faculty of Mechanical Engineering, Czech Republic*

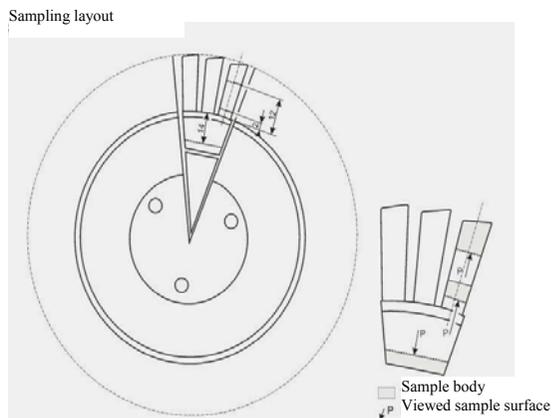
Fig.2 Sampling layout

The samples to be analyzed were taken from several blades and from the hub of the used and the new turbine wheels, as indicated on the Layout in Figure 2. The individual segments were cut using an electro-discharge cutter so that the structure of the samples remained unaffected by the cutting operation. The samples were prepared by the standard procedure and etched with the Kalling's etchant (2g CuCl_2 , 40ml HCl, 60ml 95% of ethanol).
